# The Effects of High Strength and Associated Concrete Properties on Pavement Performance

PUBLICATION NO. FHWA-RD-00-161

1. Report No. FHWA-RD-00-161		2. Government Accession No.		3. Recipient's Catalog No.	
4. Title and Subtitle The Effects of Higher Strength and Associated Concrete Properties on Pavement Performance				5. Report Date June 2001

6. Performing Organization Code	
7. Author(s) W. Hansen, E.A. Jensen, and P. Mohr				8. Performing Organization Report No.	
9. Performing Organization Name and Address University of Michigan, 2340 G.G. Brown, Ann Arbor, MI 48109-2125				10. Work Unit No. (TRAIS)

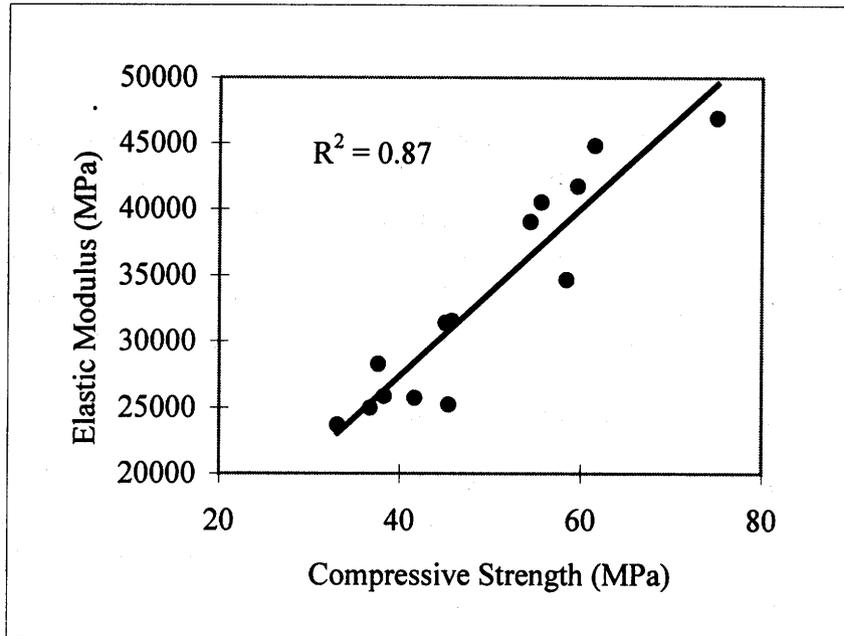
**Figure 5.4.1** Elastic modulus versus compressive strength for field samples.

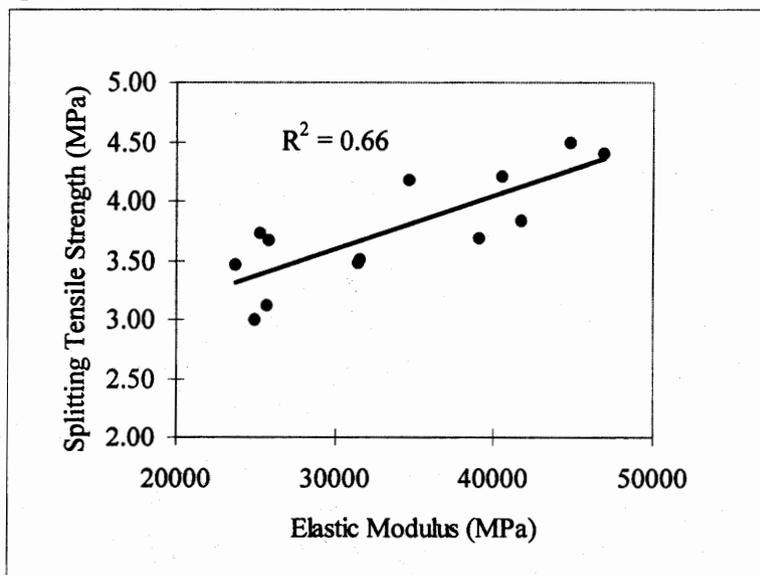
*Figure 5.4.3 Splitting tensile strength versus elastic modulus for field specimens.*

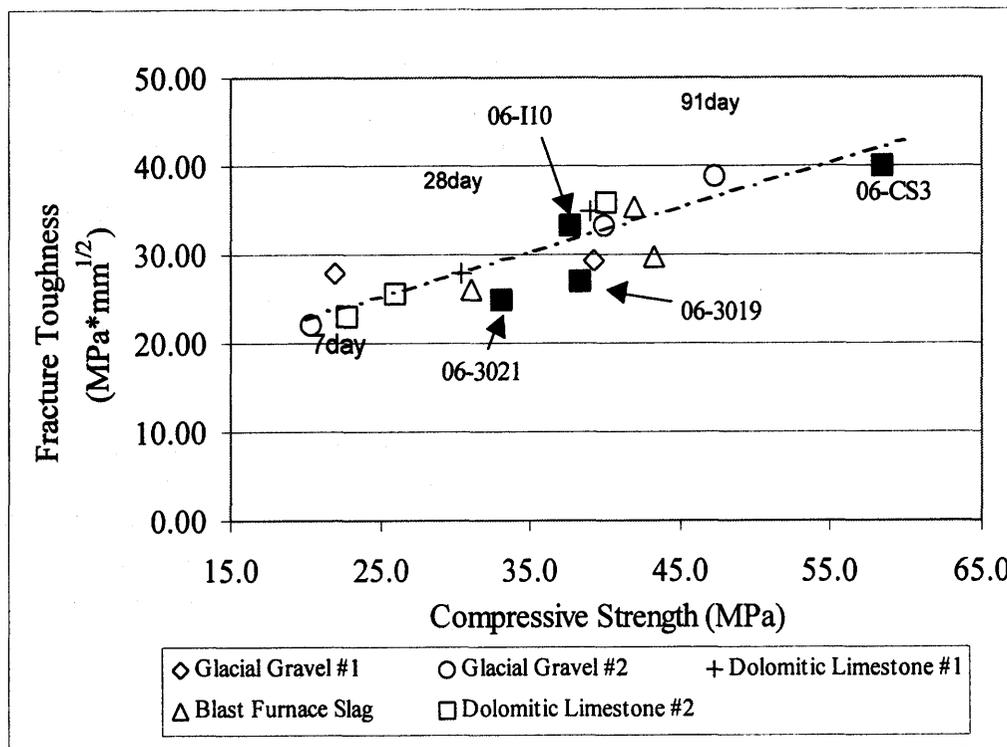
**Figure 5.5.1** Fracture toughness versus compressive strength based on data from this study and the Michigan study (965-mm span, 204-mm height, 102-mm width, 102-mm notch).

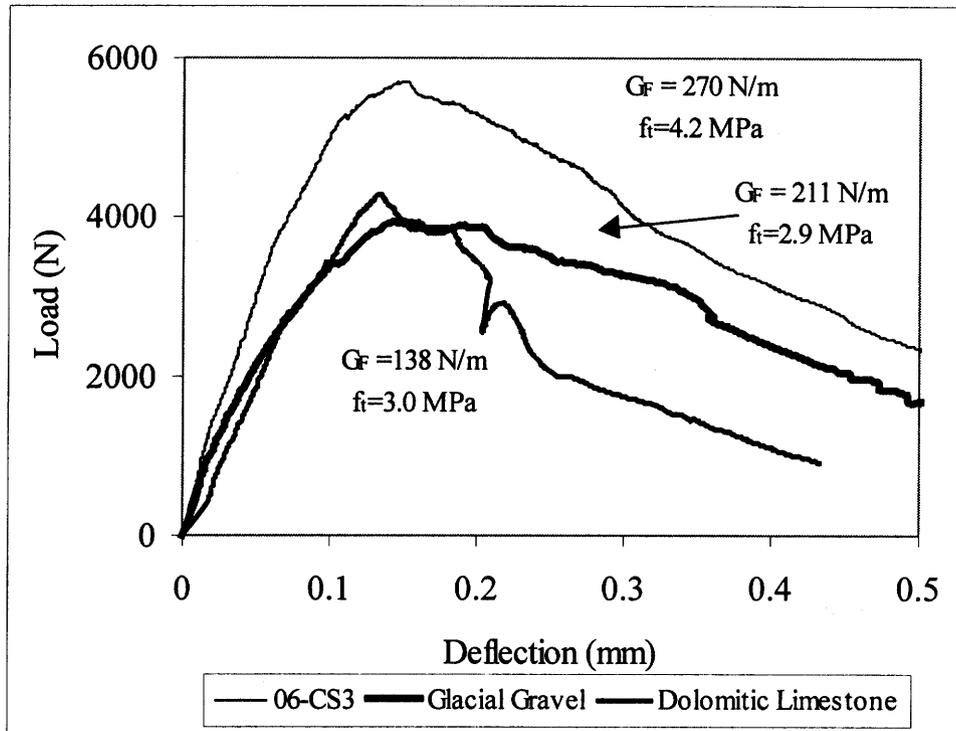
**Figure 5.5.2** Load versus deflection for laboratory and field concretes of same dimensions.

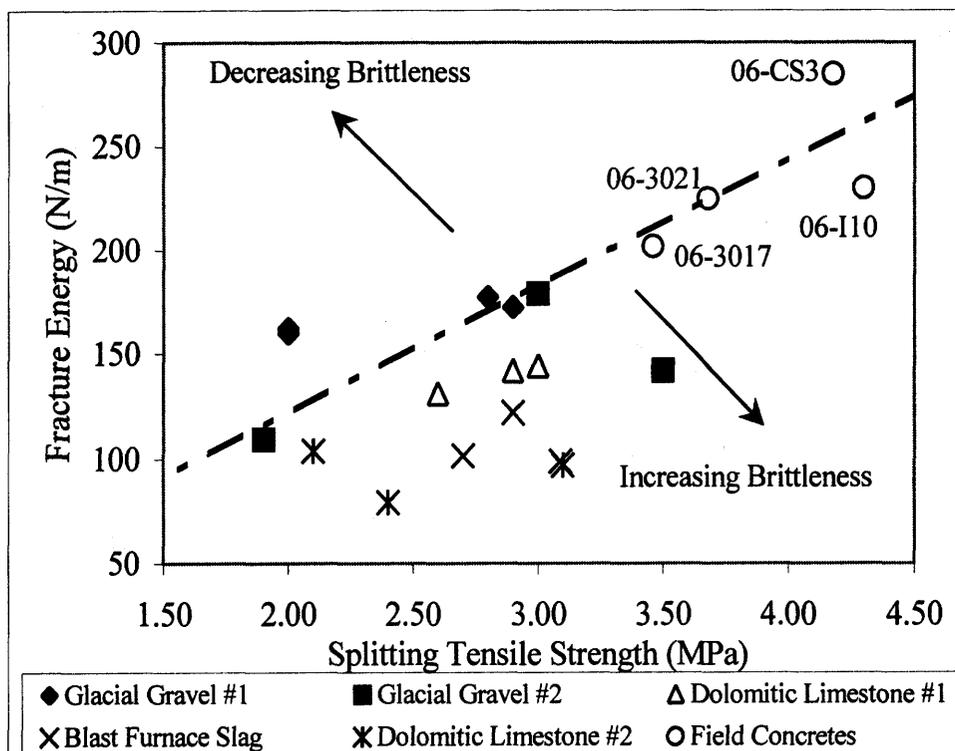
Figure 5.5.3 Fracture energy versus splitting tensile strength.

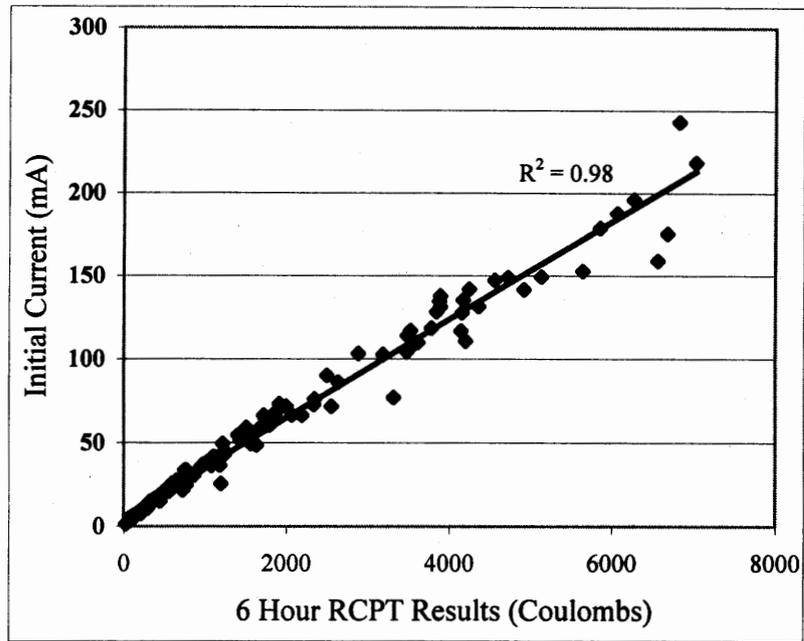
**Figure 5.6.2** Initial current values versus 6-h charge passed using the RCPT method.

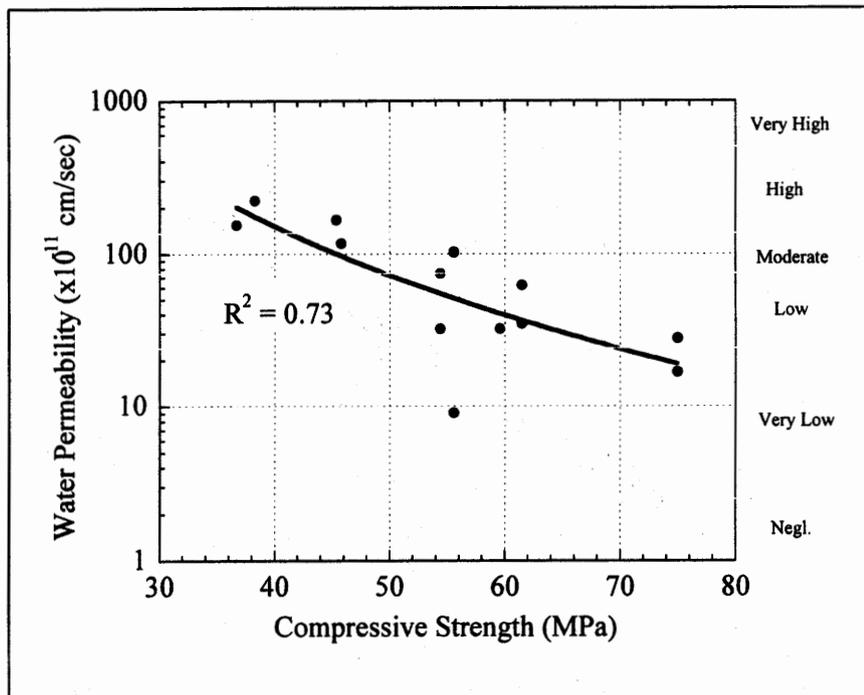
**Figure 5.6.3.** Water permeability versus compressive strength for the pavement specimens near the top of the sample.

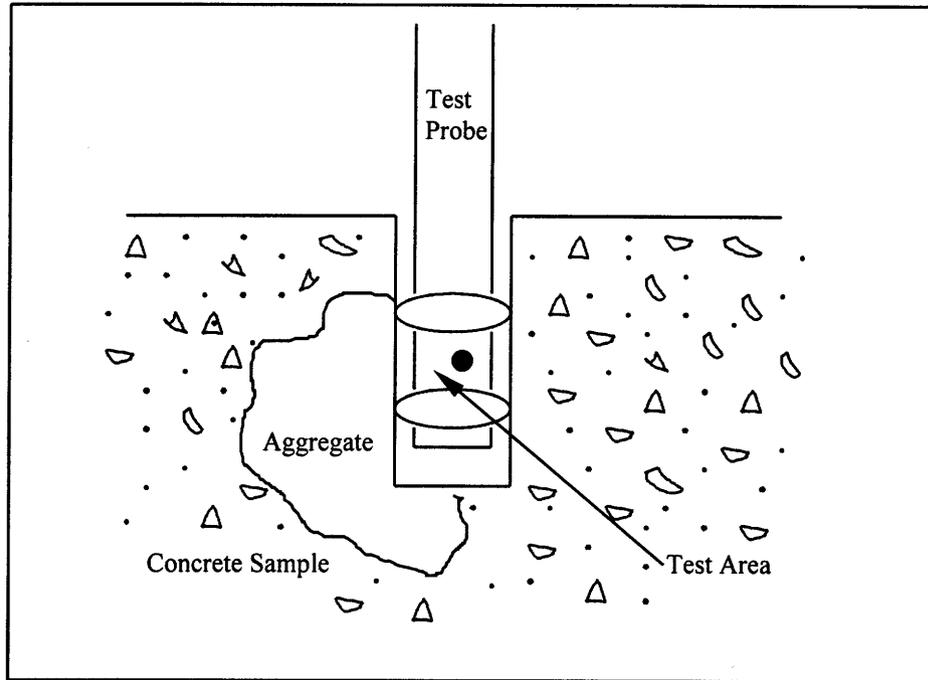
*Figure 5.6.4. Schematic of the potential influence of a large aggregate piece on the water permeability test.*

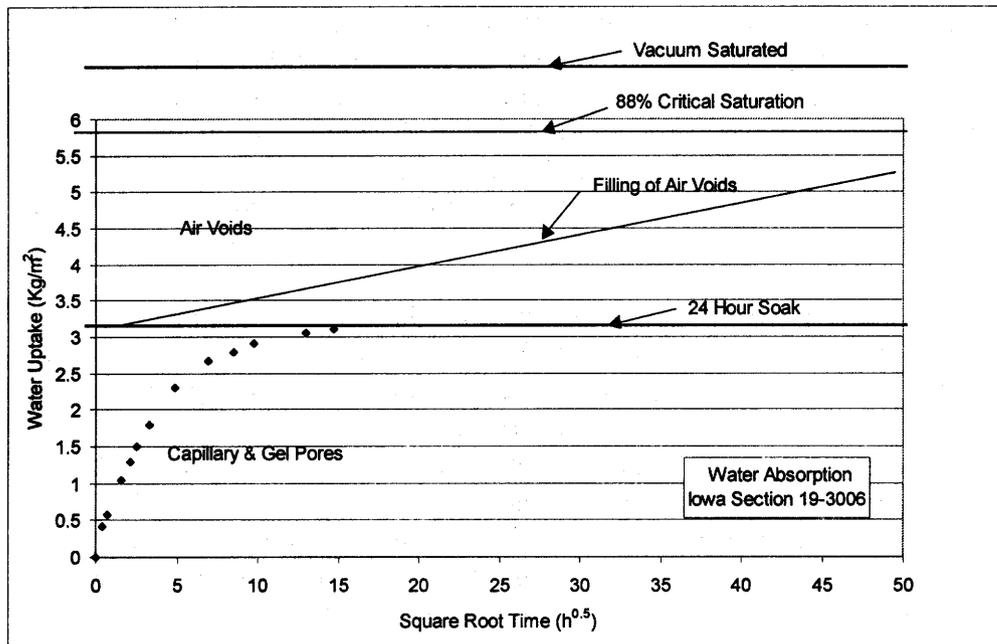
**Figure 5.6.9** Pore filling of test section 19-3006 in saturated conditions from water absorptivity test results.

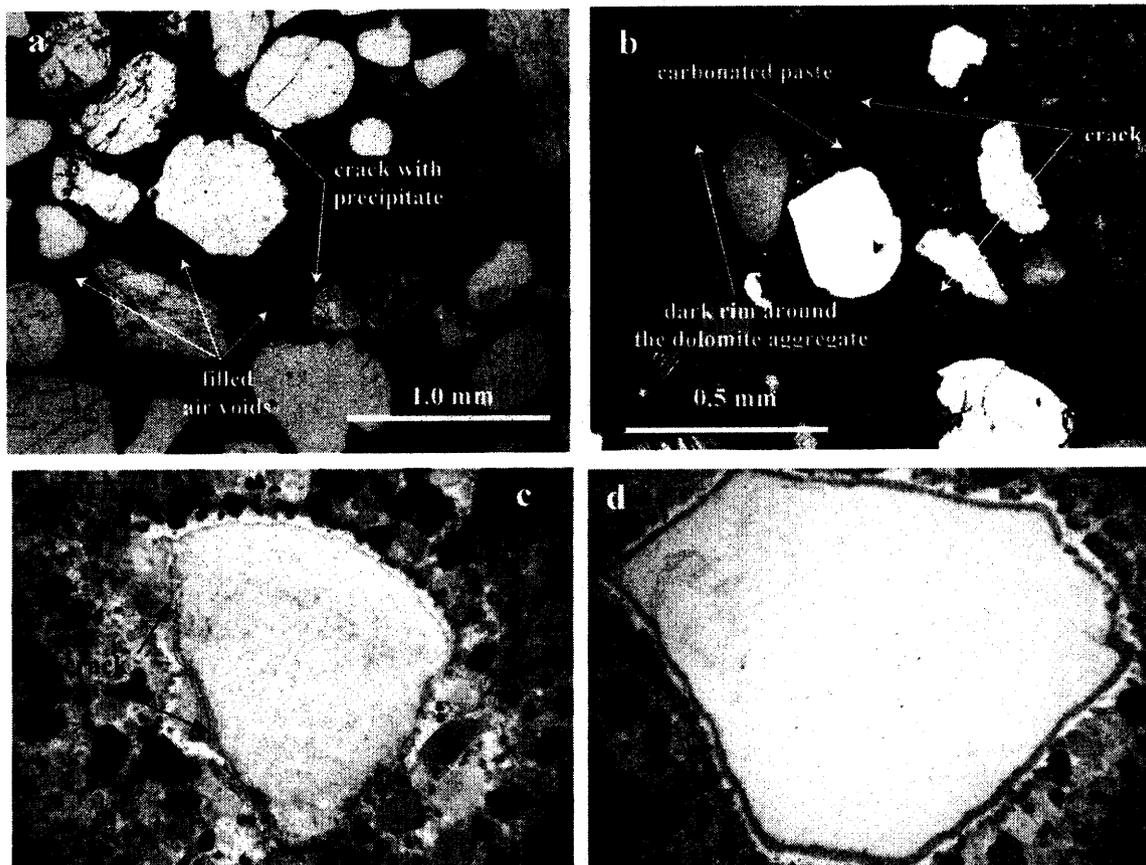
*Figure 5.7.1 a, b, c, and d) Distresses shown in section 19-3006 near the joint using low power stereomicroscopy and thin section microscopy in plane polarized light.*

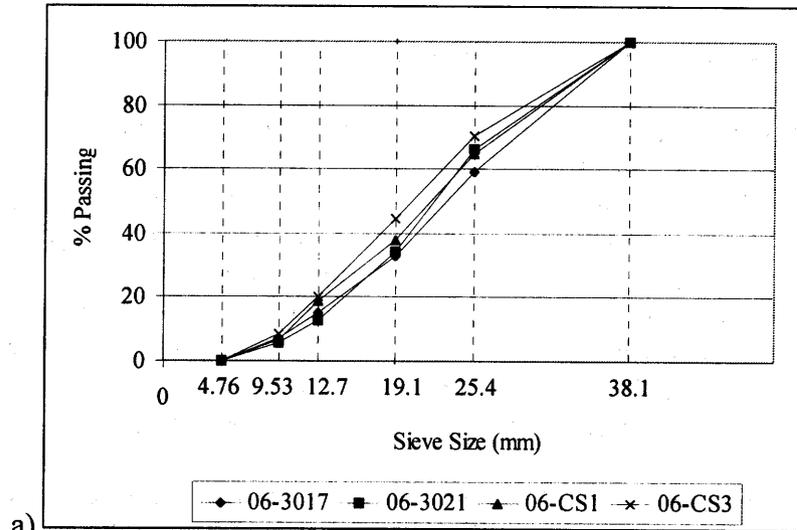
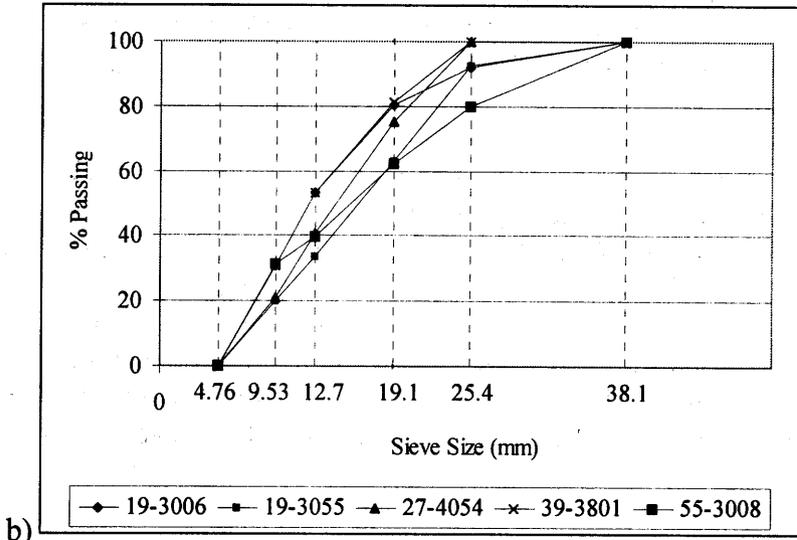
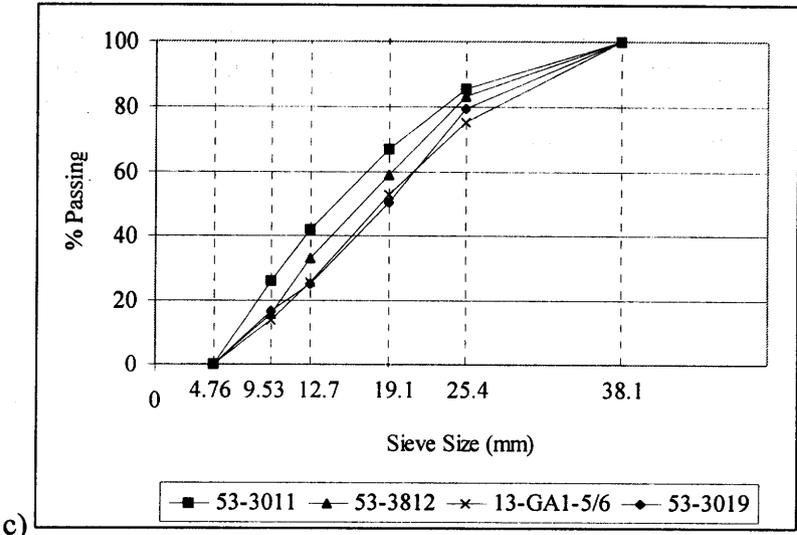
Figure 6.4.1a-c. Coarse aggregate gradation curves. a) DNF zone, b) WF zone, and c) WNF and DF zones.

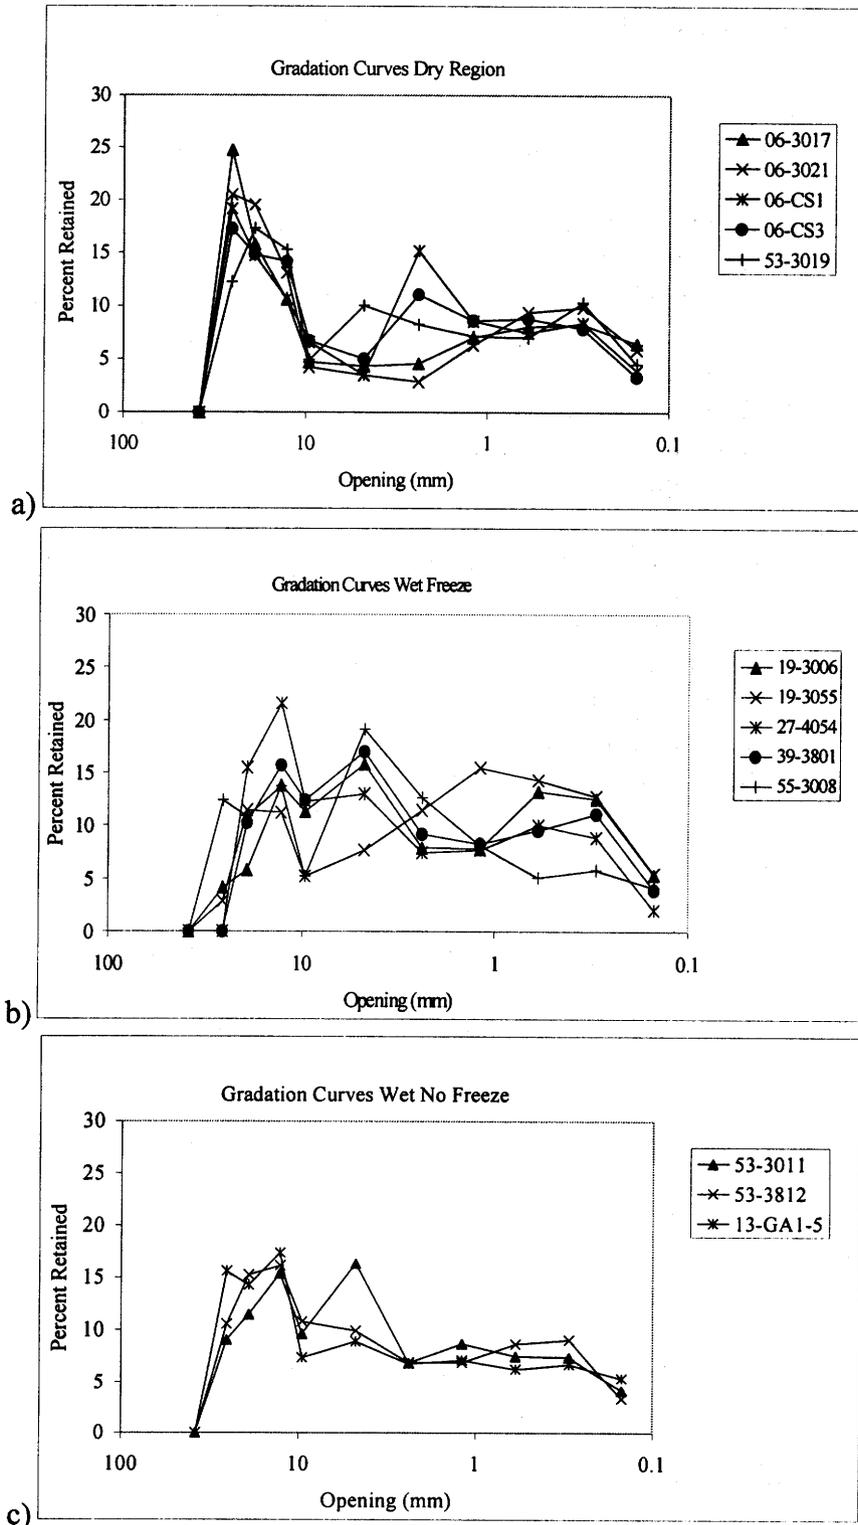
**Figure 6.4.2** Gradation curves for a) the DNF and DF zones, b) the WF zone, and c) WNF zone plotted in terms of percent weight retained.

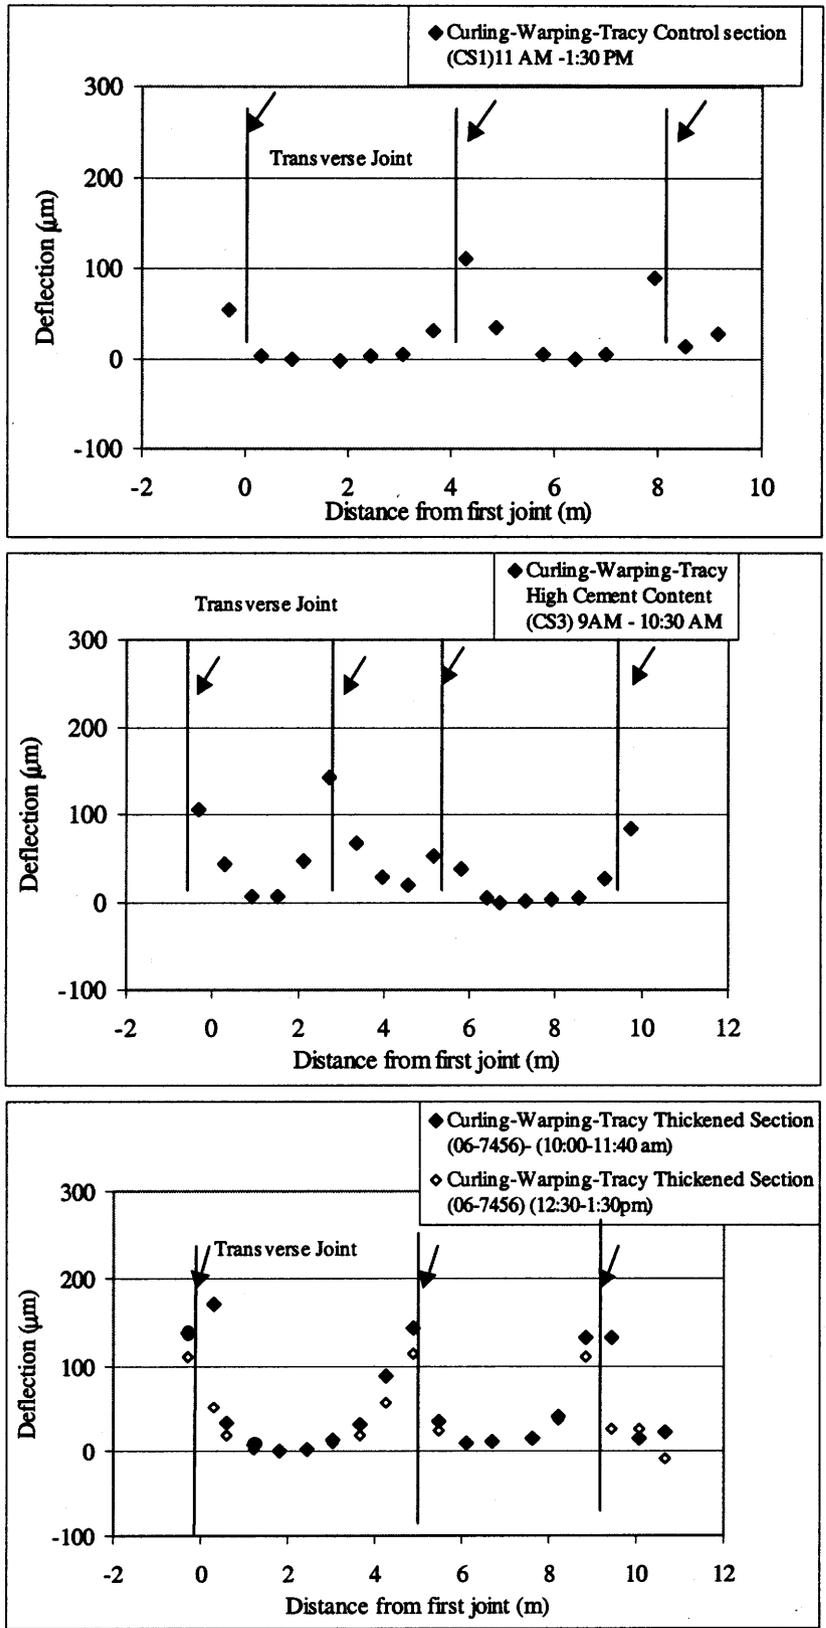
**Figure 7.1.1** Deflection profiles due to curling-warping of from the Experimental test road at Tracy, California.

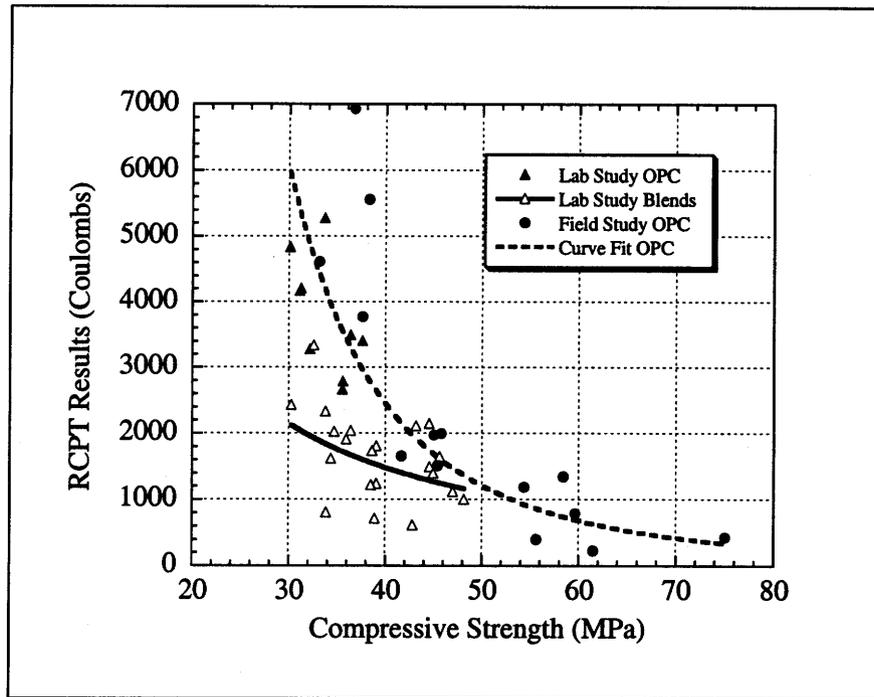
**Figure 7.5.1** RCPT results versus compressive strength for OPC's and blended cement systems from the field and laboratory studies.
